**COMMISSION FOR
HISTORICAL & ARCHITECTURAL
PRESERVATION**

STAFF REPORT

REQUEST: Demolition Hearing I – Determination of Historic Significance

ADDRESS: 5002 Frederick Ave. – Patricia Grace Thomas Inn, Sankofa CDC, Museum of the National Roadway (Baltimore City Landmark)

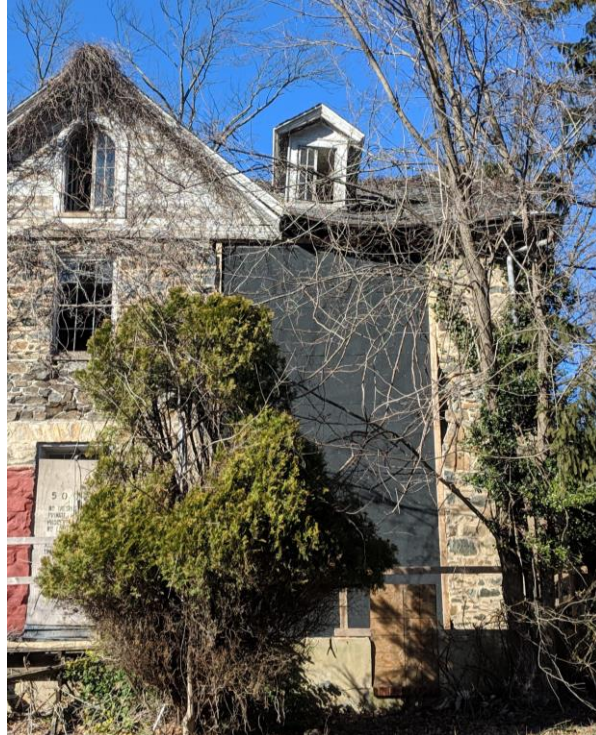
- Following a partial collapse of the stone front wall and front porch in July 2018, HABCO completed emergency demolition of the front porch and stabilization of the stone facade.

Detail of deconstructed, stabilized portion of facade, February 25, 2019

Stone walls - “Vegetation needs to be removed from the stone walls for accurate damage assessment. Missing stones will need to be replaced, and all mortar joints with section loss will need to be routed out and re-pointed. The missing wall section at the front of the building will need to be rebuilt for the entire 2 ½ story height and tied into the existing structure.”

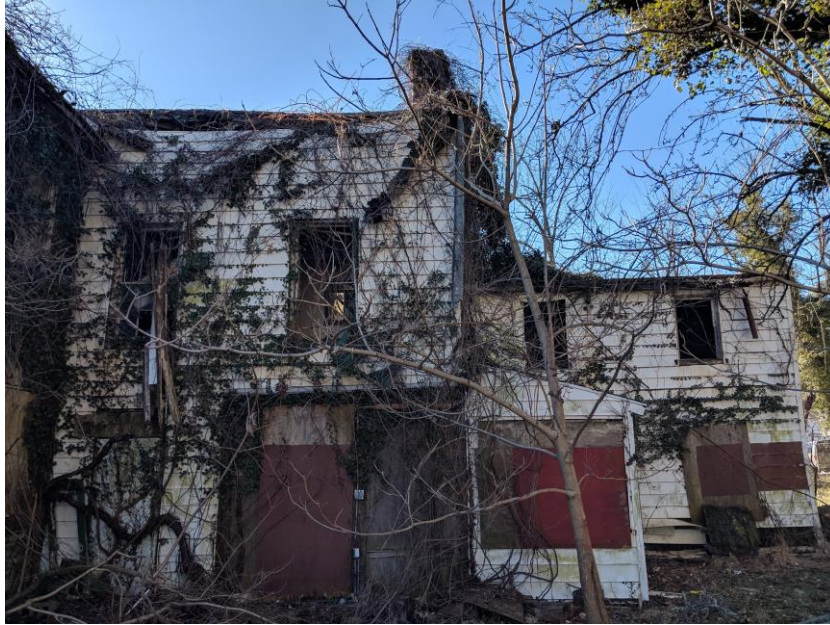
Frame additions on East elevation, February 25, 2019. There are holes in the roof. A 1 story greenhouse was previously removed from this elevation; the plywood boards delineate where it was attached to the structure.

Based on the findings of the structural report completed by KCI, CHAP staff recommends that the Commission find that the stone portions of the building still retain integrity and contribute to the landmark designation. The rear frame additions have lost structural integrity and can be demolished. Staff recommends that the exteriors of the frame additions be documented prior to demolition.

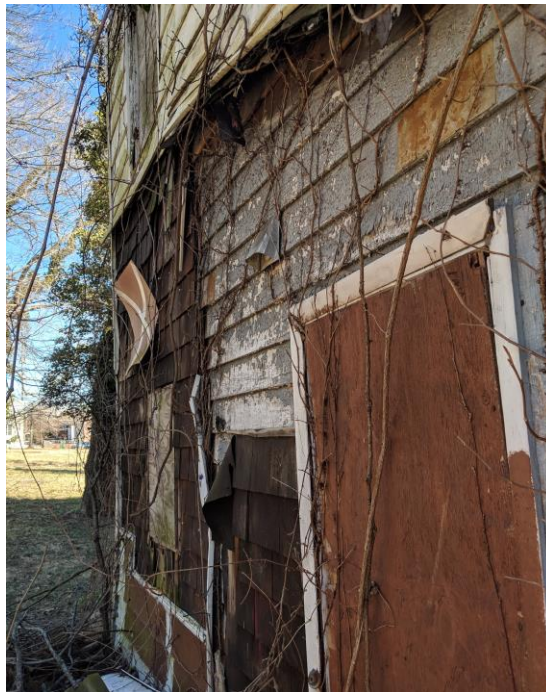
Rear elevation, February 25, 2019. Another one story frame addition was previously demolished on the rear, the removal of which shows several layers of siding including horizontal board and cedar shakes, both of which were later covered with asbestos siding. It is possible that portion that is sided with cedar shakes was originally a side porch that was later filled in.
